## Gamma irradiation of ATLAS18 ITk strip sensors affected by static charge

*The 32nd International Workshop on Vertex Detectors (VERTEX2023)*

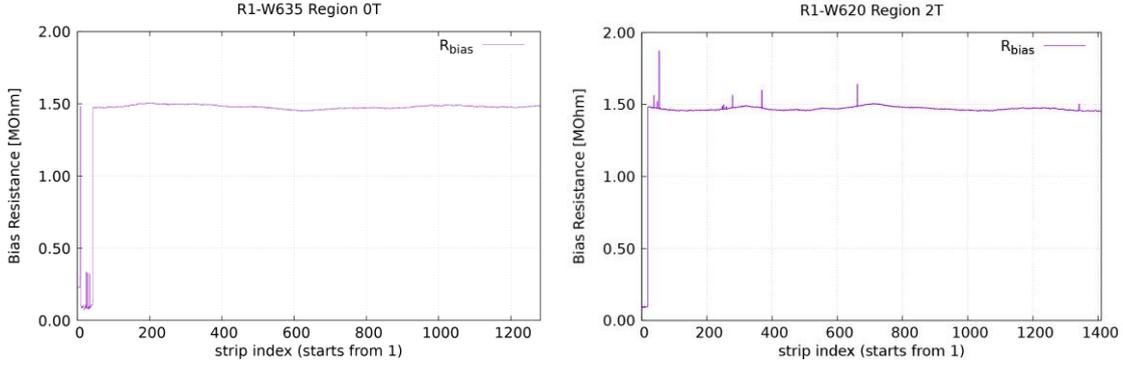
Figure 1 shows the full strip test results of bias resistance ( $R_{\text{BIAS}}$ ) of the R1-W635 and R1-W620-R sensors tested just before planned irradiation. The low interstrip isolation manifests as

areas with low  $R_{\text{BIAS}}$  values in the full strip test measuring setup. The required value of  $R_{\text{BIAS}}$  according to the ATLAS specification is  $1.5 \pm 0.5 \text{ M}\Omega$ .

**Figure 1.** Full strip tests of R1-W635 (left) and R1-W620-R (right) sensors measured after 2 months of dry storage, i.e. just before irradiation.

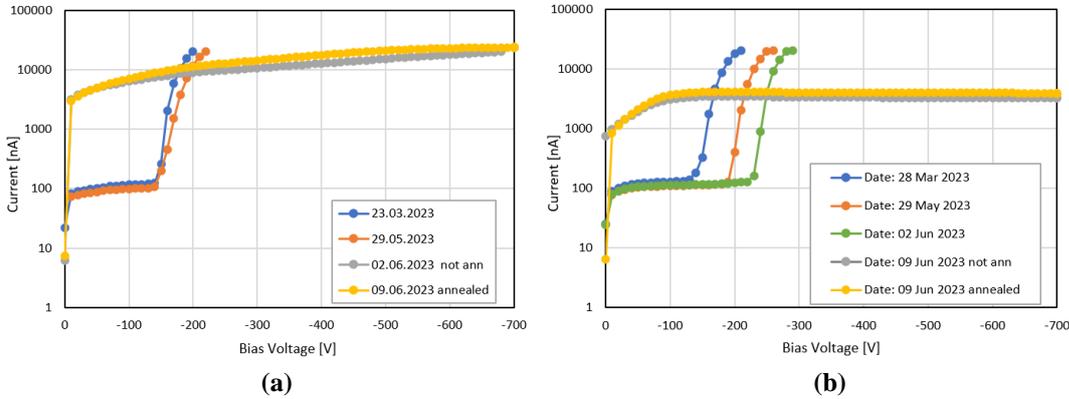
The measurements of IV characteristics after irradiation with a TID of 11 krad for sample R1-W617 are shown in Figure 2a. The IV characteristics measured before irradiation, with breakdown voltage of 150V, are also displayed. Early Break Down (BD) of sensors W617 and W607 (not shown in the plot) was no longer present after gamma irradiation to 11 krad. In Figure 2b, IV characteristics of the reference sample R1-W650-R are shown. The reference sensor R1-W650-R, which was transported and handled alongside the other sensors and was not subjected to irradiation, did not recover, as seen from the green line corresponding to the measurement on June 2<sup>nd</sup> 2023. Its breakdown voltage increased only slightly, to 250V, in comparison to the initial measurements. The leakage current of sensors irradiated to 11 krad (R1-W607 and R1-W617) increased by two orders of magnitude. Such an increase of current is expected since the measurement was performed at room temperature. In the real experiment sensors will be operated at temperatures below  $-30 \text{ }^\circ\text{C}$ . According to the previous study [8], the increase of the total current,

which comprises both surface and bulk components, after gamma irradiation is due to the increase of the surface part of the total current. The bulk leakage current increases only very little after a TID as small as 11 krad. Annealing at 60 °C for 80 minutes did not decrease the current.

**Figure 2.** IV characteristics measured before and after gamma irradiation for R1-W617 (a) and for the reference sample R1-W650-R (b).

As gamma irradiation resolved issues successfully during the initial planned step of irradiation with a TID of 11 krad (approximately one week in the real experiment), no further irradiations to higher TID values were needed. Instead, the reference samples were irradiated to an even lower TID of 1.5 krad, corresponding to one day in the real experiment. Figure 2b shows measurements performed after gamma irradiation of the reference sample R1-W650-R to 1.5 krad (gray and yellow lines measured on June 9th). The early BD observed before irradiation was no longer present even after this small irradiation. Annealing again did not help to decrease the leakage current in this case.

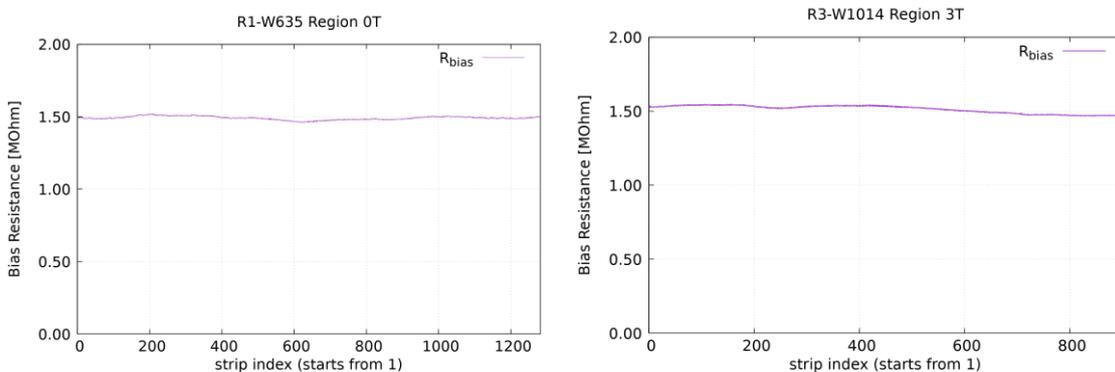
The full strip tests done after irradiation to a TID of 11 krad are shown in Figure 3. The gamma irradiation with a TID of 11 krad completely cured the low interstrip isolation areas on the sensor R1-W635 and R3-W1014. Figure 4 shows the reference sample R1-W620-R after TIDs of 1.5 and 3 krad. The reference sample R1-W620-R irradiated only to 1.5 krad has a bias resistance value of the affected strips just above the required limit of 1 M $\Omega$ , but it was not fully recovered. An additional gamma irradiation with a TID of 1.5 krad was thus applied and the results are shown in Figure 4 (right). After the TID of 3krad, the area of low interstrip isolation, manifested by a lower bias resistance value, disappeared. The few strips with increased bias resistance are issues related to non-ideal probe contact.

**Figure 3.** Full strip tests of R1-W635 (left) and R3-W1014 (right) measured after gamma irradiation of 11 krad.

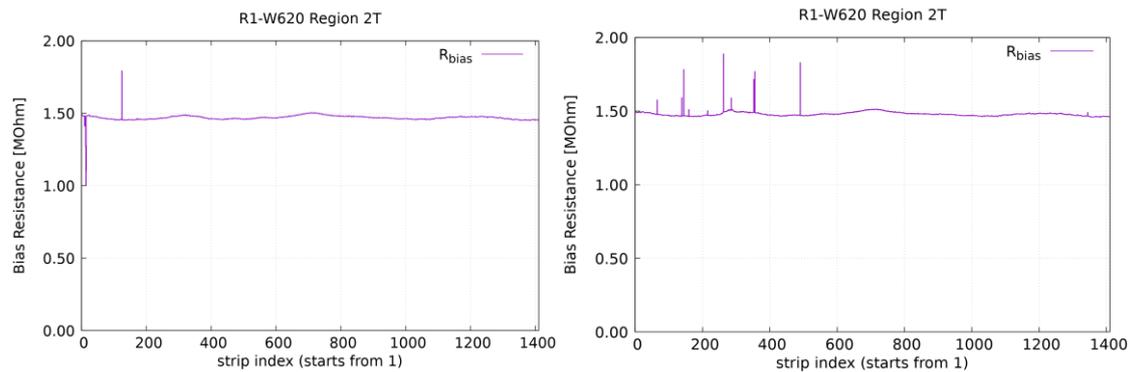
**Figure 4.** Full strip tests of R1-W620-R sensor measured after the total delivered ionizing dose of 1.5 krad (left), and 3 krad (right).
