Horn Operational Experience in K2K, MiniBooNE, NuMI and CNGS

This paper gives an overview of the operation and experience gained in the running of magnetic horns in conventional neutrino beam lines (K2K, MiniBooNE, NuMI and CNGS) over the last decade. Increasing beam power puts higher demands on horn conductors but even more on their hydraulic and electrical systems, while the horn environment itself becomes more hostile due to radiation. Experience shows that designing horns for remote handling and testing them extensively without beam become prerequisites for successful future neutrino beam lines.

*10th International Workshop on Neutrino Factories, Super beams and Beta beams
Valencia, Spain
30 June – 05 July, 2008*

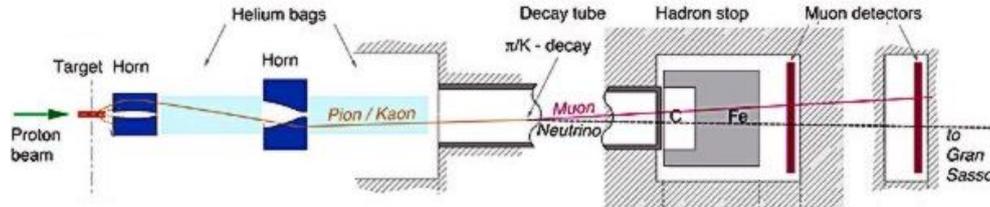
The present-generation conventional neutrino beam lines use one or more magnetic horns to focus the charged particles emitted from the target (Figure 1).

Figure 1: Main components of the CNGS neutrino beam line, with two magnetic horns.

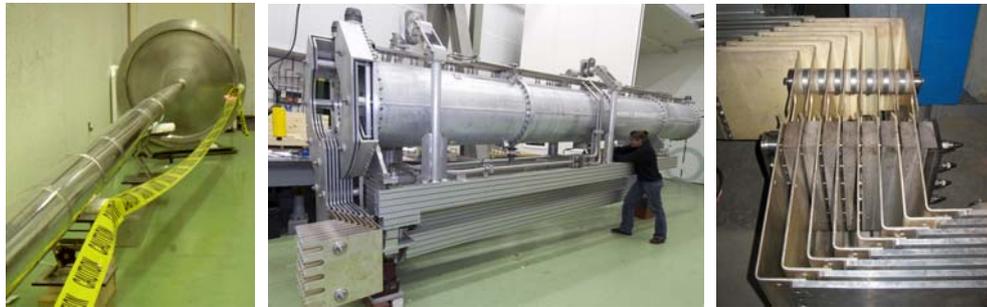
A horn is a high-current, pulsed focusing device aimed at increasing the intensity and selecting the energy of a neutrino beam. A modern horn (Figure 2a-c) consists of a water-cooled aluminium inner and outer conductor, connected to a power source by parallel busbar plates.

Figures 2a-c: CNGS horn inner conductor, assembled horn and horn-busbar connection.

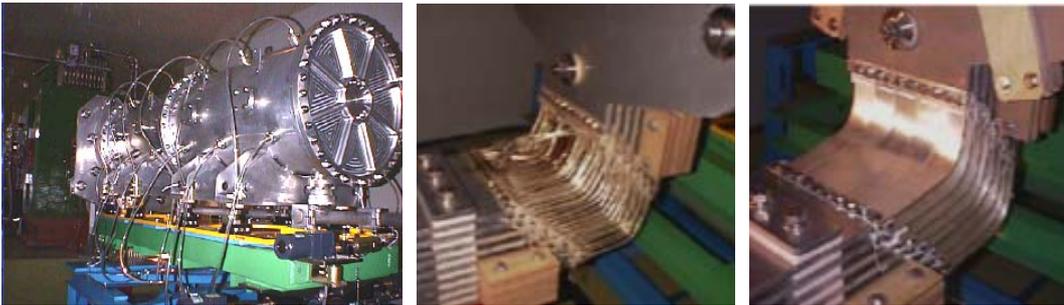
During its five years of operation, the K2K beam line saw two major horn failures, both in the first year. The first was a leak in a cracked weld on the straight water inlet pipes, induced by fatigue stress from cyclic thermal expansion of the horn outer conductor to which they were attached. Figure 3a shows the new semi-flexible pipes that were installed on all following horns to absorb the thermal expansion. The second failure occurred in a semi-flexible busbar connection consisting of twisted copper cables, where strong magnetic forces between conductors of different polarities deformed the cables (Figure 3b) and caused a short circuit. The cables were successfully replaced with more rigid plates as shown in Figure 3c.

Figures 3a-c: K2K horn new water lines, faulty and new horn-busbar connection.

Horns were exchanged preventively every year, as long as the radiation level in the horn area allowed it. In summer 2004, radiation levels in the area made the exchange impossible. Three months later, a horn inner conductor broke from fatigue, defining the end of K2K.

- Protect water input lines from vibrations of the outer conductor.
- Take magnetic forces into account when designing busbars and other conductors.
- Design future horn for remote exchange.

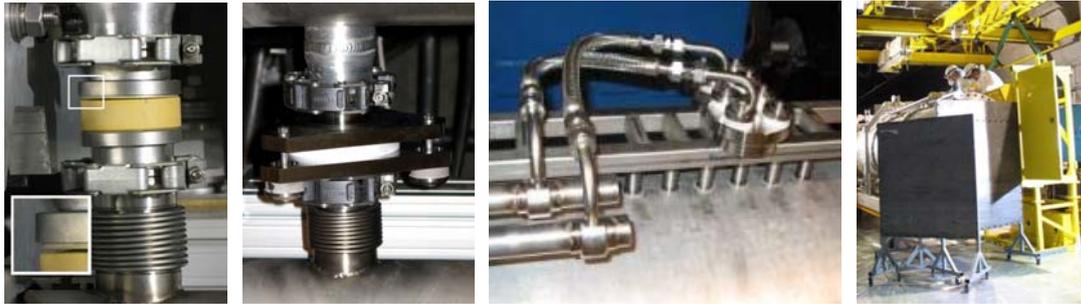
After half a million pulses and a month of beam, a water leak appeared in the second (most downstream) horn's cooling circuit. One of the horn's electrically insulated brazed water outlets had a broken ceramic muff, as visible on Figure 4a. Analysis shows that the thin ceramic muff was weakened from machining and brazing. As a consequence, the relatively small forces from the horn pulsing sufficed to break the ceramic. A brazing-free alternative, where leak tightness

Figures 4 a-d: Faulty and new water outlet, new water inlets and in-situ intervention.

is ensured by pressing soft graphite seals on a ceramic ring (Figure 4b-c), was installed. All brazed assemblies (outlets and inlets) were preventively replaced on both horns in a makeshift shielded area upstream of the target (Figure 4d). To reduce the personnel radiation dose, the intervention was carefully optimized and practised beforehand on the spare horn.

At the same time, a small fracture was discovered in one of the cables and some strands of the semi-flexible connection between busbar and transformer in the technical gallery. Since the magnetic forces seemed to have broken the brazed section of the cable, all cables were replaced with more solid plates, clamped together by insulators to better absorb the magnetic forces.

- Avoid brazing in the ceramic insulating assemblies of the cooling circuit.
- Invest in tooling, training and local shielding in case of local interventions.
