SOFA: a new approach for quality assurance in GEM-foils

This work presents the development of Software (SOFA hereafter) for morphological quality assurance in GEM-foils (electrodes of a GEM-like detector) through the analysis of high resolution images. SOFA (Software for Foils Analysis) performs an automated measurement of the holes geometry presented in the GEM-foils, in order to detect and quantify different defects far from their ideal geometric characteristics. This work underlines the speed, automation and precision of SOFA regarding quality visual inspection used in manufacturing process of GEM-foils. SOFA is a R&D tool, because its measurements allow establishing relation between GEM-foils defects and GEM-like detector performance.

*38th International Conference on High Energy Physics
3-10 August 2016
Chicago, USA*

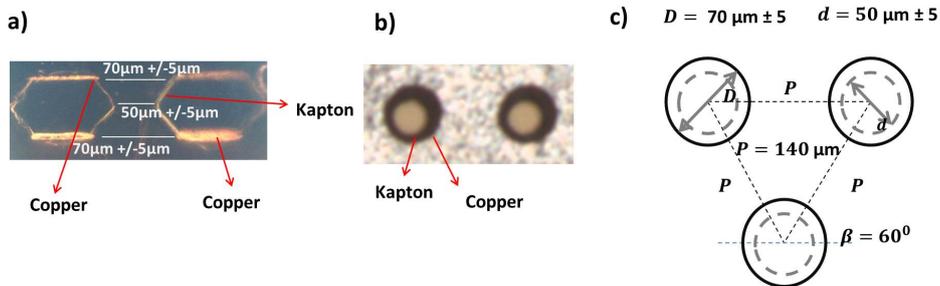
Figure 1: GEM-foil cross section and holes geometry. (a) Cross section of GEM-foil, (b) High resolution image of two holes, (c) Image describing the geometric distribution scheme.

Figure 1-a shows a GEM-foil cross section with biconical holes and hexagonal pattern: $70 \pm 5 \mu\text{m}$ in both layers of copper and $50 \pm 5 \mu\text{m}$ in the kapton layer. Figure 1-b shows an image of a hole taken from above and perpendicular to the plane of the hole. Because light reflection effects in holes, they are seen as uniform thick rings, the external perimeter corresponding to diameter of the hole in copper layer, and internal diameter corresponding to Kapton layer. Figure 1-c shows the geometric distribution scheme of the holes in the foil and its idealization with infinite resolution.

A GEM-foil is a uniformly perforated thin foil, formed by three consecutive layers Copper-Kapton-Copper 5, 50 and 5 microns thick respectively. The holes are only a few microns in diameter and they are homogeneously distributed in a very dense pattern (micro-pattern) [1]. The dimension, shape and allocation of the holes in a GEM-foil vary by purpose. The importance of detecting defects, imperfections and irregularities of the holes, is associated to the local electric field distribution in the GEM-foil, subsequently disturbing the avalanches of local charges and then the quality of the information generated by the detector [2]. In this work, the geometric parameters of the holes were compared to an ideal hole geometry and pattern in GEM-foils [3].

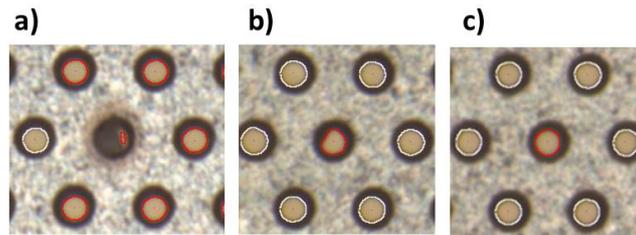
As already mentioned, SOFA evaluates radius, roundness and eccentricity of the holes to identify irregularities in the GEM-foil structure. Figure 2-a shows a kind of defect that is easily identified by VI and it is identified by SOFA using circularity as measure. Figure 2-b shows a defect that is difficult to identify by VI, but it is detected by SOFA using radius measuring, in other words a faulty hole is pinpointed by SOFA, whereas a standard VI can be limited. Figure 2-c represents a successful case of identification of defects by SOFA using the varying of the radius as comparative parameter, contrariwise this kind of defect is impossible to identify by VI.

Figure 2: Typical irregular (in-red) and ideal (in-white) micro-pattern holes geometry. (a) Defect easily identified, (b) Defect difficult to identify, (c) Defect impossible to identify.

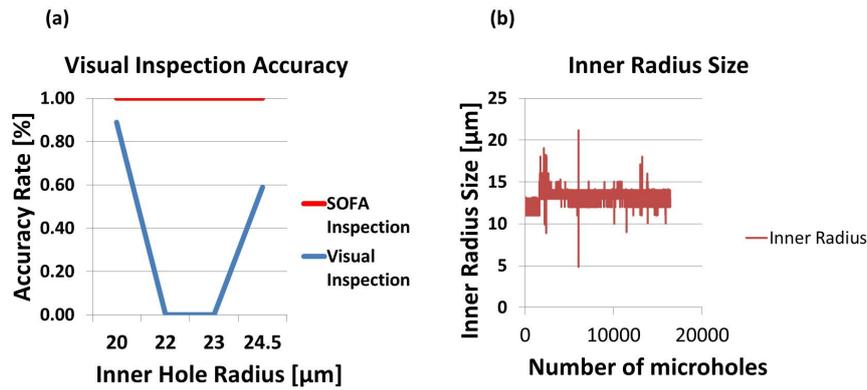
By sampling a large set of high resolution images, the VI identified 98% of the variations if the radius is less than $20 \mu\text{m}$ and identifies 60% of the variations if the radius is greater than $24.5 \mu\text{m}$ as shown in Figure 3-a. In turn, for these images the VI has an accuracy rate of 0% if the variations are between 22 and $23 \mu\text{m}$ because the VI cannot detect variations equals to 1. Figure 3-b shows the distribution of the value of internal radii in micrometers for 16386 holes where the most between 12 and $15 \mu\text{m}$, an important contribution as quality parameter provided by SOFA.

Figure 3: SOFA performance. (a) Visual inspection accuracy. (b) Distribution of the value of internal radii in micrometers.
