Radiation damage test of MPPC by a 290 MeV/u C beam at HIMAC

We present the damage of MPPC by a 290MeV/u C^{6+} ion beam generated by the HIMAC accelerator. We used two types of MPPC, S10362-11-050C(400pixel) and S10362-11-100C(100pixel) manufactured by HAMAMATSU Photonics K.K. We irradiated MPPCs with C^{6+} beam, which intensity was changed from 10 to 10^7 (particle/mm²/s). We measured output charge from the MPPCs at each dose using stationary Xe light source.

International workshop on new photon-detectors PD07

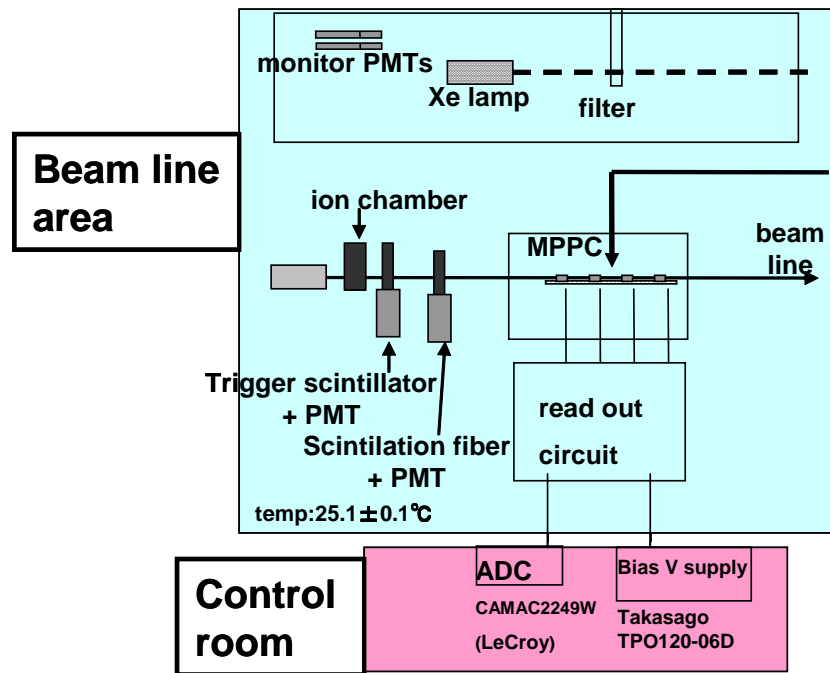
Figure 1: Schematic view of this experiment. Blue region shows the beam line area. Pink region shows the control room.

Fig. 1 is a schematic view of this experiment. Four MPPCs placed along the beam line were exposed at the same time. The beam intensity was changed from 10 to 10^7 (particle/ mm^2/s), corresponding to 0.05Gy/h - 50kGy/h for dose rate at MPPCs. Irradiation was done at low beam intensity, and later at gradually higher intensity. Finally 1.2×10^{10} particles(corresponding to 16kGy) were exposed to MPPCs.

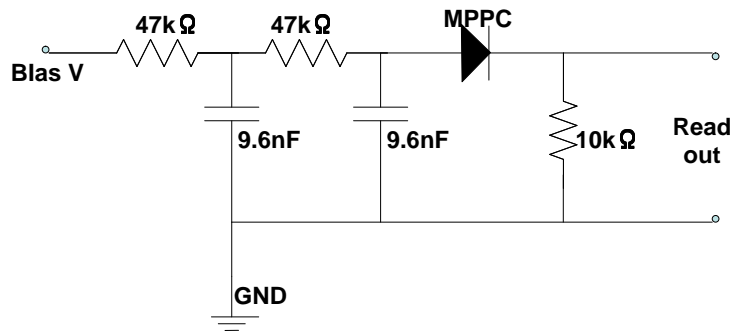
Figure 2: Diagram of the read out circuit.

Beam intensity was monitored by an ion chamber calibrated by scintillator and scintillation fibers at low intensity. The output charge from MPPCs was read by a read out circuit shown as Fig. 2 then was recorded by ADC(CAMAC 2249W) at each dose by flashing Xe lamp with several tens of photons through optical fibers. Temperature in the black box which MPPCs were located was kept 25.1 ± 0.2 degrees Celsius during the exposure.

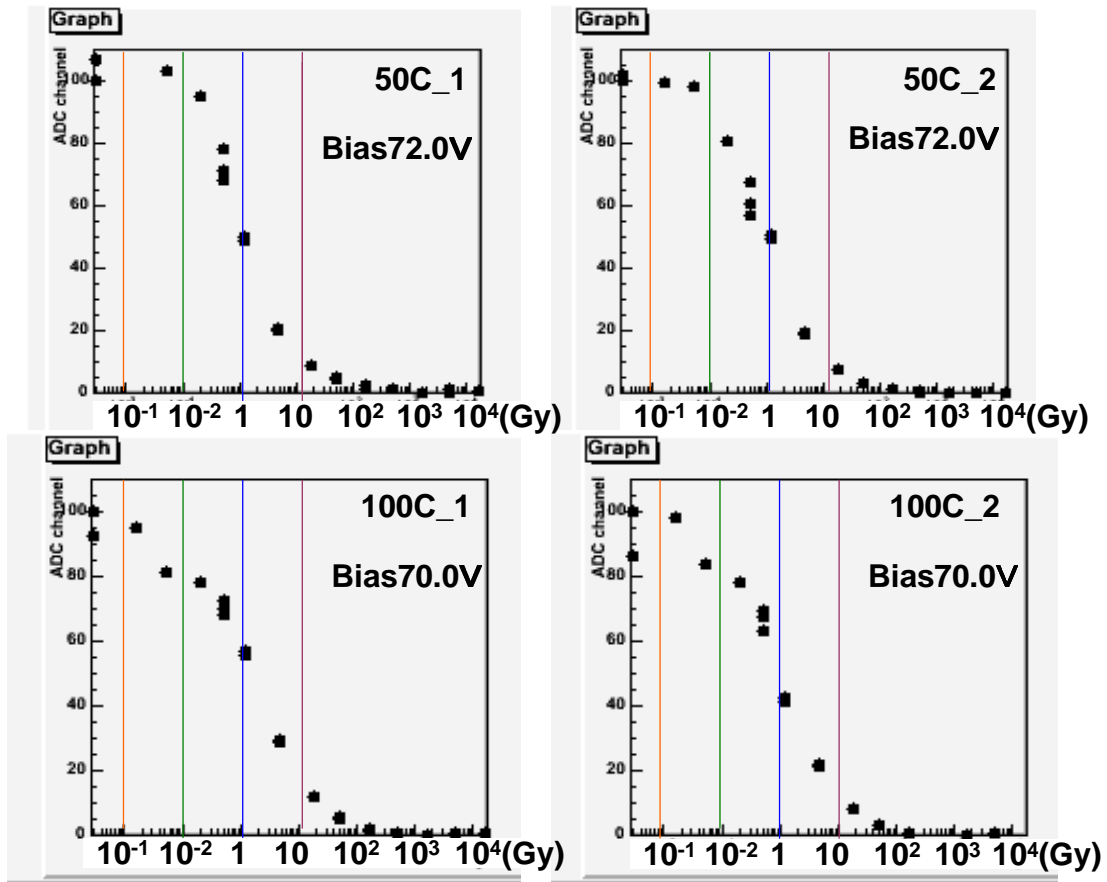
Figure 3: Radiation damage of 4 MPPC samples. Upper 2 figures show the damage for 2 samples of S10362-11-050C(50C_1, 50C_2). Lower 2 figures show the damage for 2 samples of S10362-11-100C(100C_1, 100C_2).

The result is shown in the Fig. 3. In this figure, we can see the output charge from MPPCs decreased as amount of beam exposure increased. In all samples, counts of ADC decreased by half after 1Gy irradiation, which corresponds to exposure of $7.5 \times 10^6 C^{6+}$ ions . After 100 Gy irradiation, signals from all 4 samples were not detected anymore.
